Oregon Public Utility Commission
Salem, Oregon

Incident Investigation Report

Incident Number:	2016-10-19 NWN NW 23 rd & NW Glisan
Type of System:	Gas Distribution
Incident Type:	Pipeline Damage, Explosion and Fire
Location:	Portland, Oregon
Date of Failure:	October 19, 2016
Time:	9:38 a.m.
Owner/Operator:	Northwest Natural Gas
Fatalities:	None
Injuries:	1
Property Damage and Losses:	\$17,220,182 ¹
Material Released:	Natural Gas
Pressure:	50 psig
Type of Failure:	Excavation Damage
Component Affected:	1-inch steel service line
Root Cause of Incident:	Insufficient Notice to the Oregon Utility Notification Center by Loy Clark Pipeline Co.

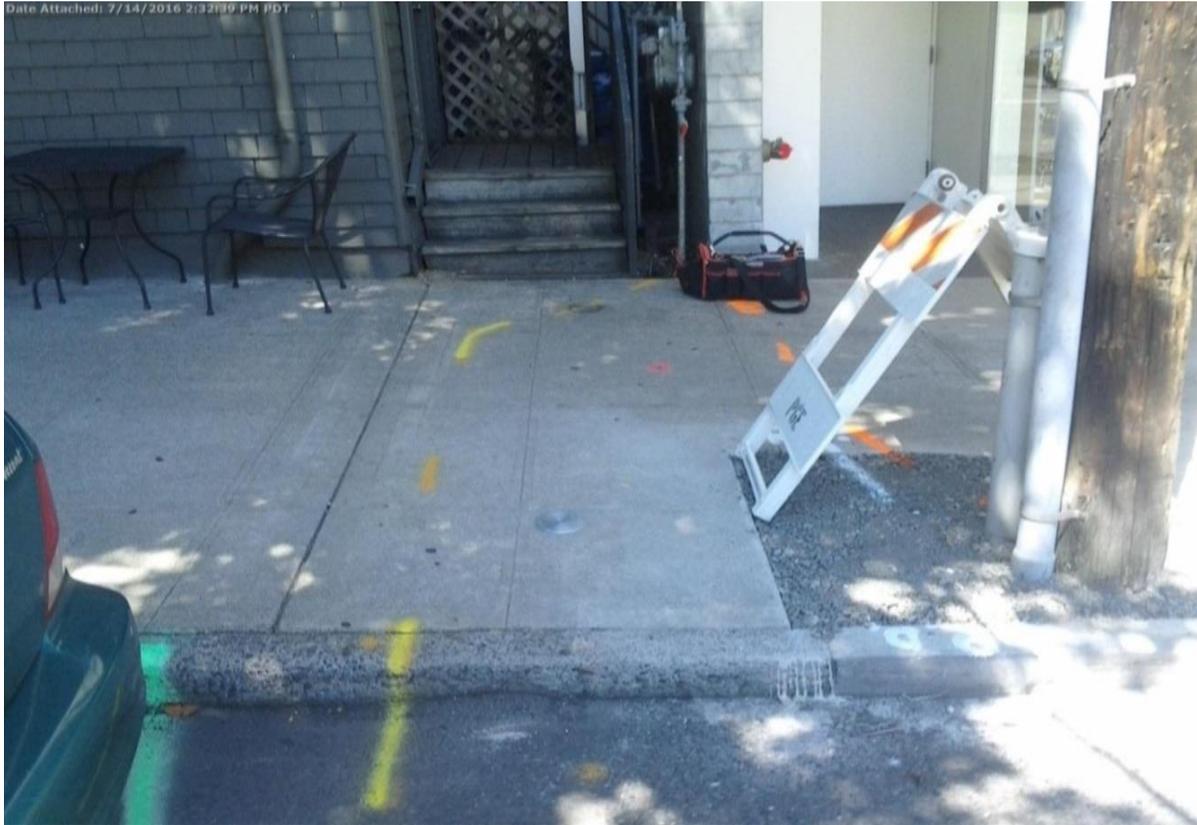
Figure 2 – Locating Inc. documented completed locates on July 14, 2016 at 2:32 p.m. Above is the sidewalk taken facing north from NW Glisan prior to PGE and Loy Clark Pipeline opening an excavation in conjunction with city permit #65193. The natural gas service line is clearly visible showing a complete field location of the service line between 500 NW 23rd Avenue (building on the left) and 2281 NW Glisan Street (building on the right).

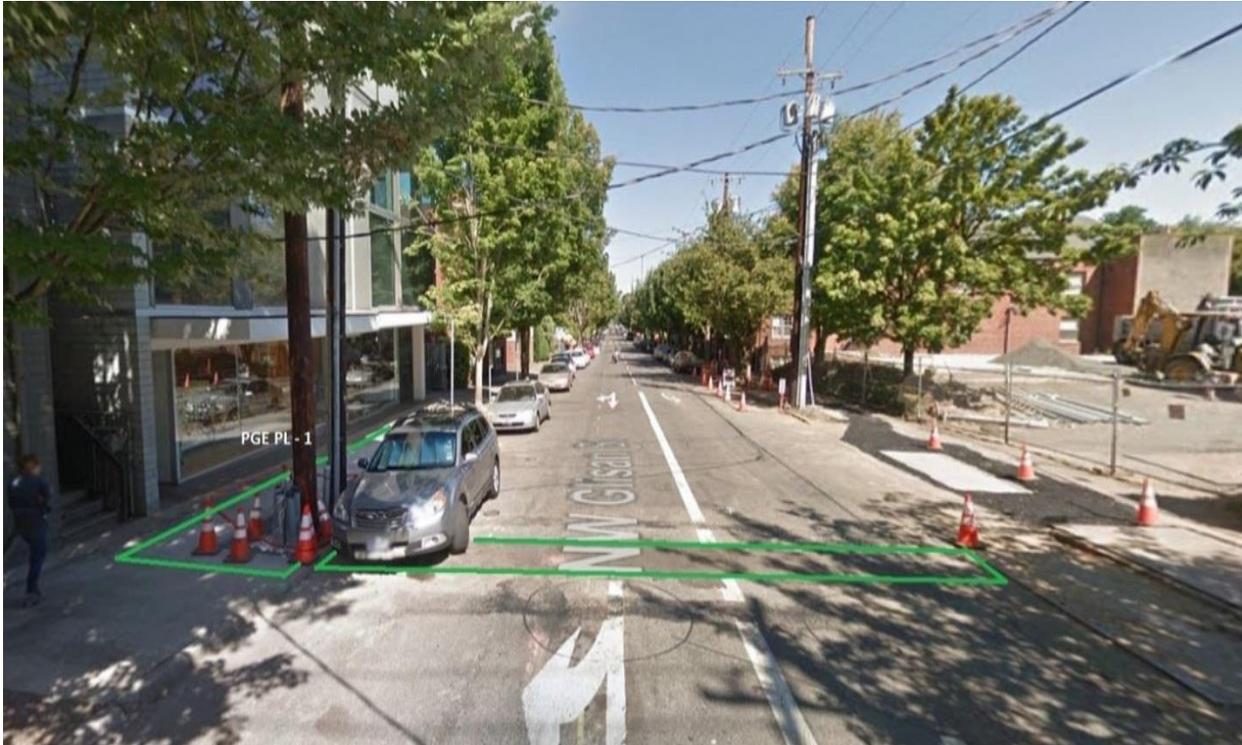
Figure 3 – Google Street view facing East on NW Glisan – Shows PGE PL-1, risers installed by Loy Clark on the North side of Glisan, Restored street and sidewalk surfaces (highlighted in green) across NW Glisan Street and from PL-1 to PGE Vault – 95 in front of 2281 NW Glisan Street.

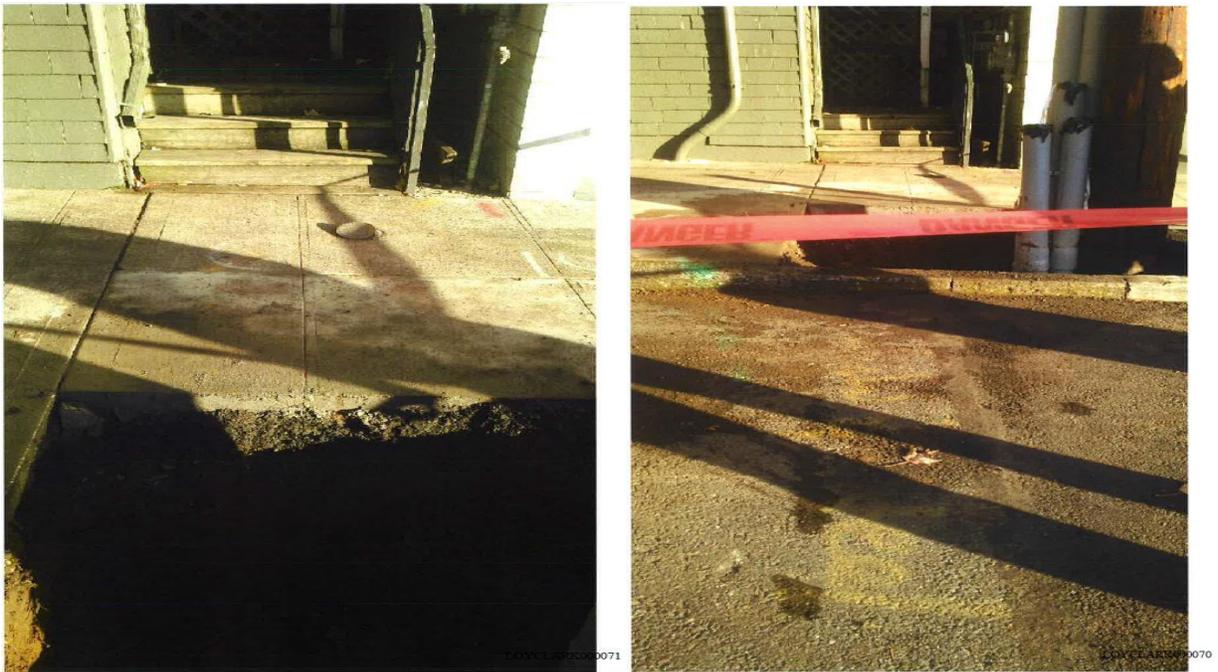
On the morning of October 19, 2016, Loy Clark Pipeline began to excavate on the *north* side of NW Glisan by removing a section of the sidewalk that was restored around the area of PGE PL-1. Permit #65996 allowed the installation of a junction box, to the left of risers attached to PGE PL -1. The immediate area of this excavation activity was not identified by Loy Clark Pipeline when it notified the OUNC on September 12, 2016. As such, OUNC subscribers did not mark the location of facilities in this area. Consequently, Loy Clark Pipeline did not have clear visible field location information or markings to indicate the presence and direction of all hazards prior to removing the sidewalk. At approximately 30-inches of depth, Loy Clark Pipeline damaged and pulled an unmarked 1-inch steel natural gas service line. According to Loy Clark Pipeline personnel, it notified NW Natural at 8:48 a.m. of the leaking gas. A member of the excavation crew took photographs of the sidewalk and hole adjacent to PGE PL-1. As can be seen in Figure 4, there is a lid over a valve for the gas line. The venting of natural gas was enough to cause the lid to hover over the opening.

Figures 4 and 5 – Photographs obtained from Oregon OSHA, taken by Loy Clark Pipeline after striking the Natural Gas Service line. The valve lid (also in Figure 2) is between two faded markings. Loy Clark Pipeline did not have clear visible field locations in order to identify the presence and direction of the natural gas service line beneath restored section of sidewalk.

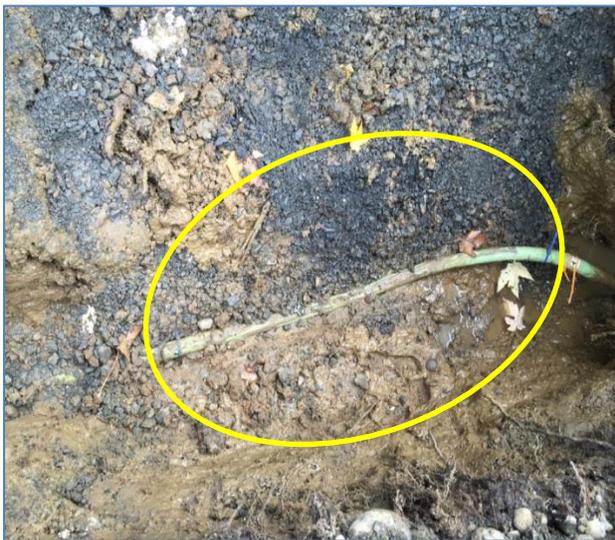
NW Natural Gas personnel then exposed the service line and valve using non-invasive excavation methods. The damage on the service line measured approximately 38 inches in length at a depth of 30 inches from the top of the sidewalk. It appeared mechanized excavation equipment caused “damage” to the extent the pipe needed to be repaired or replaced due to weakening, partial or complete destruction, including the protective coating (see Figure 6 and 11). The line had been pulled from a connection at the Dresser valve, more than four feet away. It was then revealed the location of the severed valve connection was “upstream” and before the closing mechanism on the Dresser valve body (see Figure 7). This disconnection provided an uncontrolled release of natural gas from the service line.

Figure 6 - Damaged service line

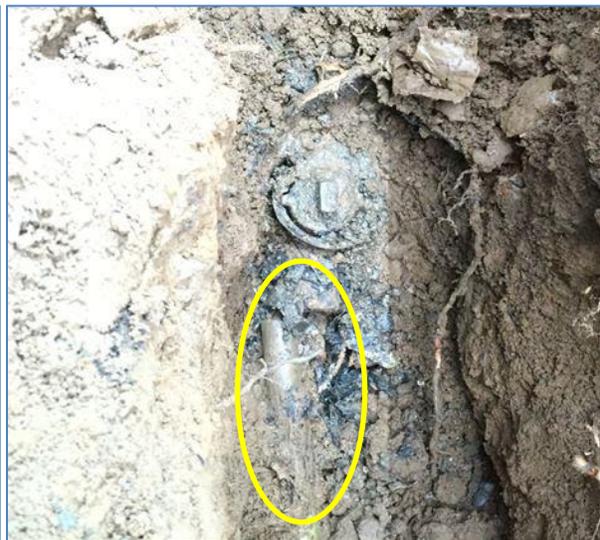
Figure 7 – Severed Dresser valve connection

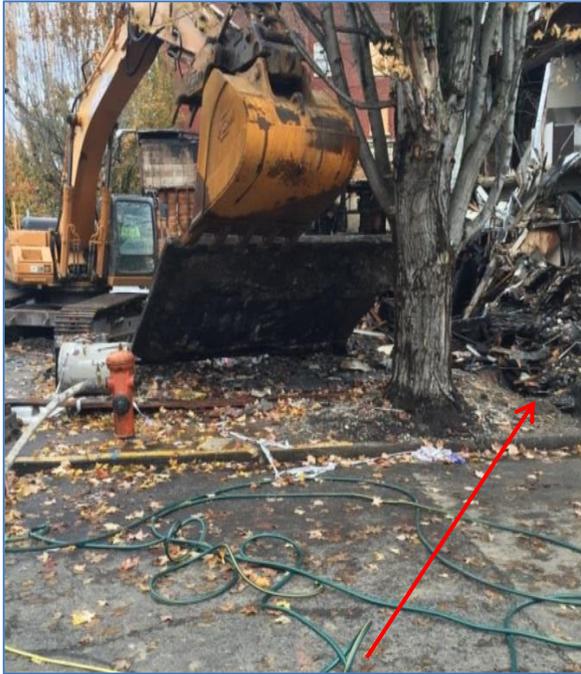
At the time of damage, the gas likely vented through paths of least resistance: the valve lid and migrated under the sidewalk. During the inspection and recovery of the pipeline, a section of sidewalk was removed and a vault was found in the right-of-way (see Figure 8, 9 and 10 below). The vault’s opening

adjoins the basement at 500 NW 23rd Street the most likely path of travel of natural gas into the building was through cracks and gaps between the vault walls and sidewalk.

Figure 8 – Sidewalk removal revealed vault in the right-of-way

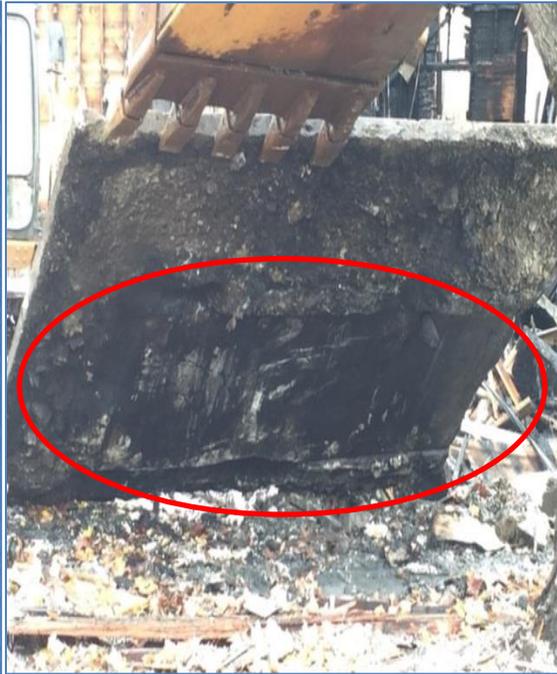
Figure 9 – Bottom of sidewalk was a ceiling surface of vault

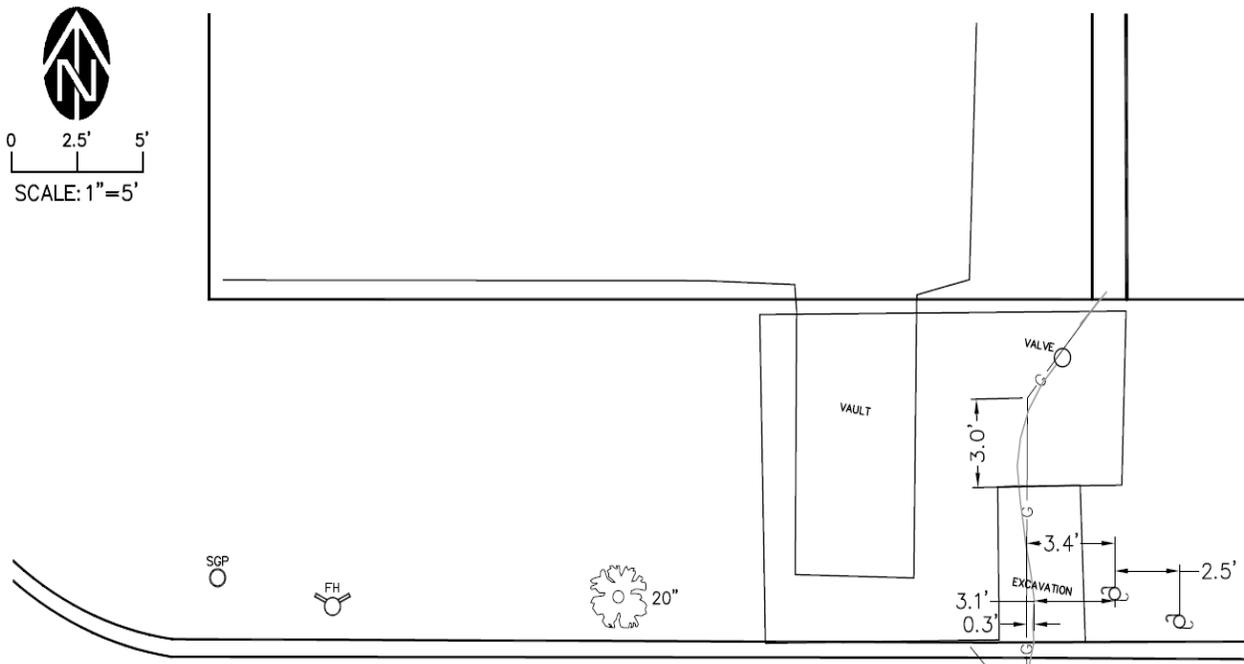
Figure 10 – NW Natural’s site survey of vault, excavation area, valve, and service line.

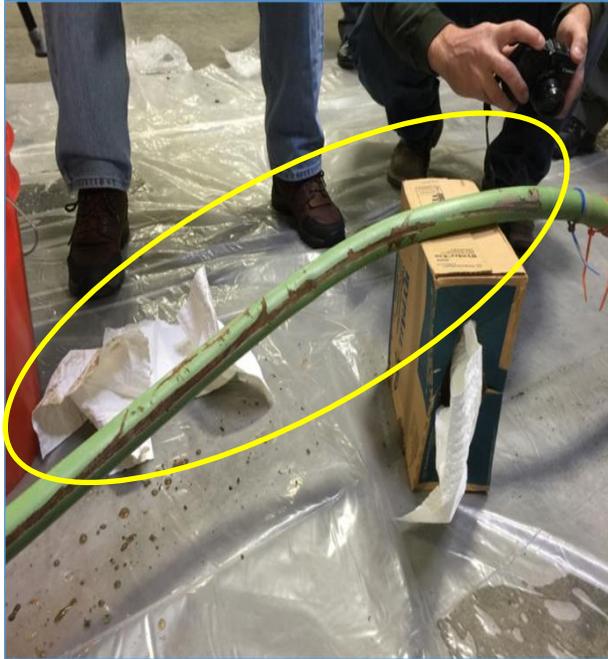
On November 16, 2016, Safety Staff was present for the inspection of the service line, valve and the meter bank that had been moved to the service center. Safety Staff observed cleaning dirt and debris from the service line (see Figure 11). A closer examination of the service line confirmed the pipe was damaged where excavation had taken place.

Figure 11 - Damaged Service line

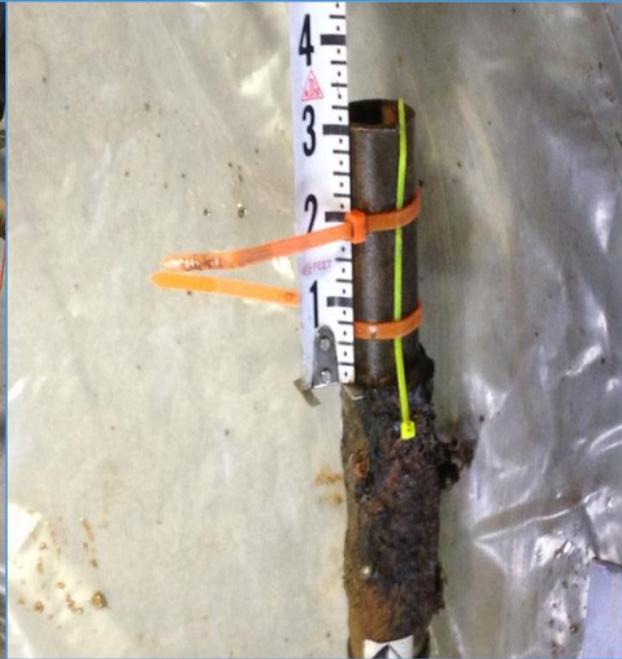
Figure 12 – Service line that was severed from the valve connection

Inspection of the valve body showed a manufacture stamp “175 1GTO.” The pipeline surface that was pulled from the fitting was visually examined and measurements were taken. The inserted depth into fitting was measured to be approximately 3-inches (see Figure 7). The outside diameter at the end of the pipe measured 1.316-inches.
