Oregon Public Utility Commission
Salem, Oregon

Incident Investigation Report

Incident Number:	2016-10-19 NWN NW 23 rd & NW Glisan
Type of System:	Gas Distribution
Incident Type:	Pipeline Damage, Explosion and Fire
Location:	Portland, Oregon
Date of Failure:	October 19, 2016
Time:	9:38 a.m.
Owner/Operator:	Northwest Natural Gas
Fatalities:	None
Injuries:	1
Property Damage and Losses:	\$17,220,182 ¹
Material Released:	Natural Gas
Pressure:	50 psig
Type of Failure:	Excavation Damage
Component Affected:	1-inch steel service line
Root Cause of Incident:	Insufficient Notice to the Oregon Utility Notification Center by Loy Clark Pipeline Co.

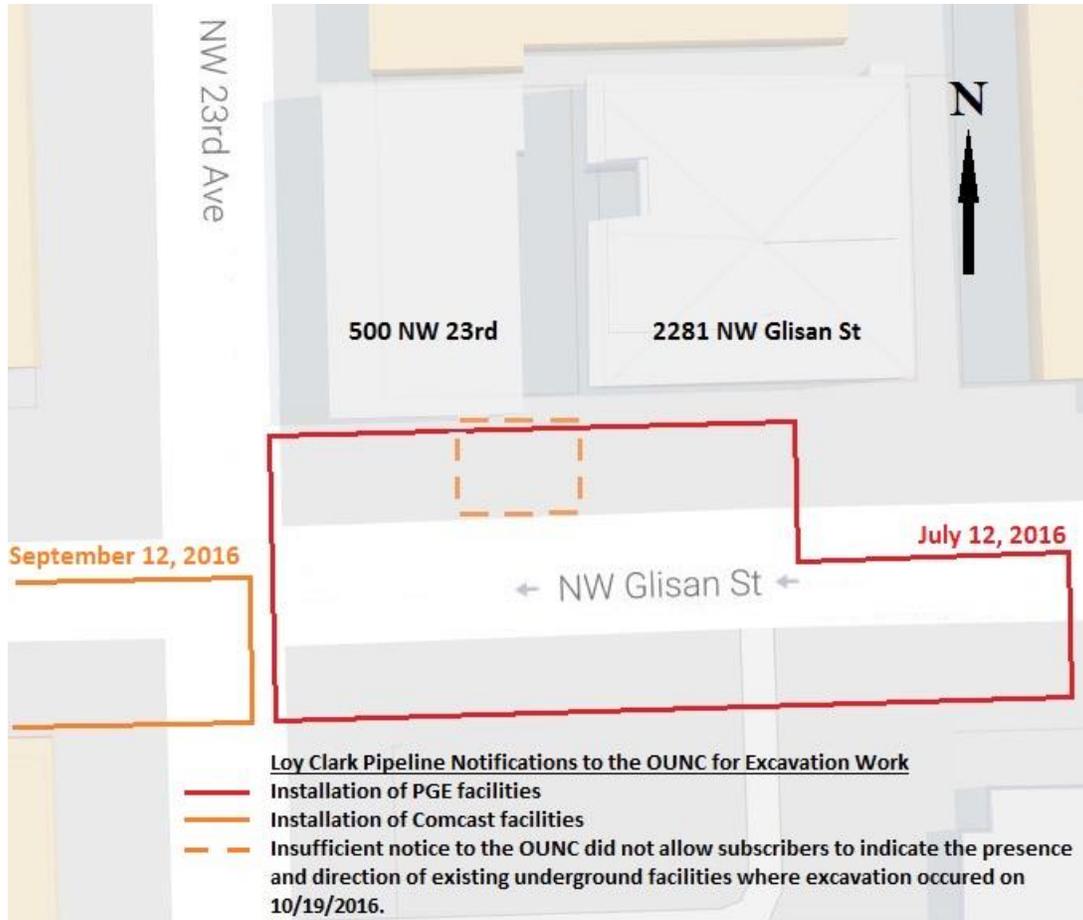
Figure 1

When Loy Clark Pipeline called the OUNC to provide notice of the excavation to be performed on behalf of Comcast, the person gave notice for work on the south side of NW Glisan Street (see Figure 1). Safety Staff finds the prior work conducted by Loy Clark Pipeline for PGE, in the same area, provides context for the October 19, 2016 incident that is the subject of this investigation.
